**Flood Control Project Maintenance
Levee Inspections****LMA District Cover Sheet****Spring 2015 Levee Inspection Results****Reclamation District No. 0544 Upper Roberts Island**

Spring 2015 Levee Inspection Results

Reclamation District No. 0544 Upper Roberts Island

Waterway			Bank	Unit Miles
Unit No. 01 San Joaquin River			Left	6.05
	Spring (March - May)	Summer (June - August)	(September - November) Fall	Winter (December - February)
Unit Maintenance Rating (Fall Only)				
Date of Inspection	04/28/2015 - 04/28/2015			
DWR Inspector	Richard Willoughby			
Accompanied By

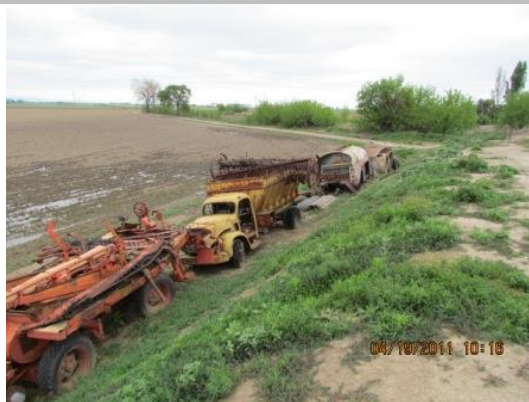
Photo 2 of 3 : SP_2015_RD0544_108_4_20150309_00003.jpg

Looking north at equipment along landside toe.

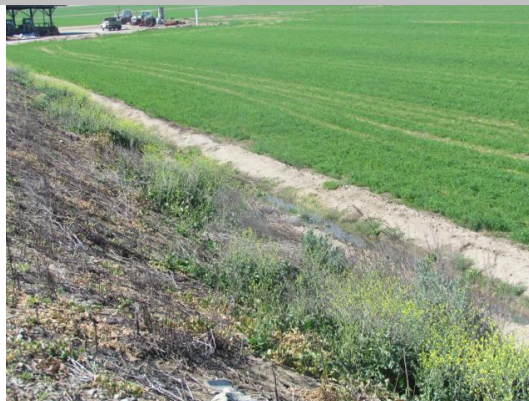
Photo 1 of 1 : SP_2015_RD0544_108_85_20150430_00072.jpg

Looking southwest at Irrigation ditch at landward toe.

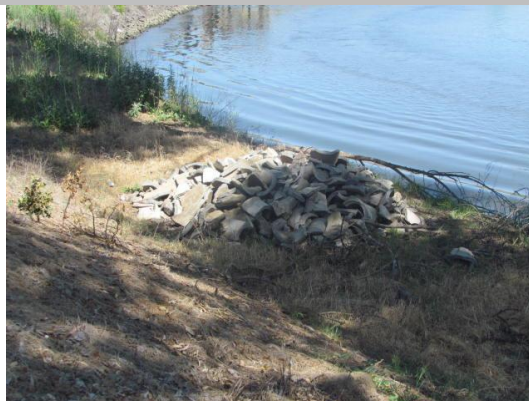
Photo 1 of 1 : SP_2015_RD0544_108_1_20150430_00073.jpg

LM Start	0.45	Rating **	M	Issue No.	1
LM End	0.45	Issue Type +	En	Location *	WS
Category	Earthen Levee			GPS Latitude/Longitude	
				Start	End
Item	Encroachments			37.864713 °	37.864713 °
				-121.326708 °	-121.326708 °
DWR ID	DWR_RD0544_01_f_2013_1				
Action/Comments					
Material					
Inspector Comments: Old broken concrete pipes on waterward berm.

Looking northeast at broken concrete piping on waterward berm.

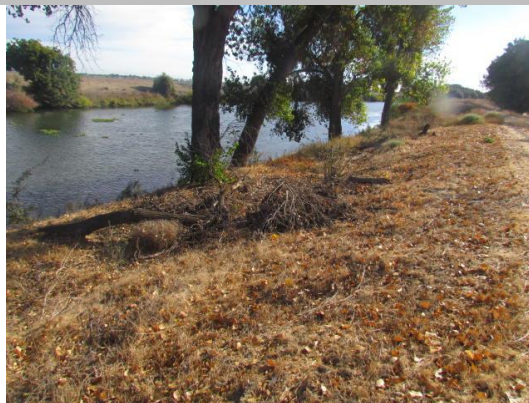
Photo 1 of 1 : SP_2015_RD0544_108_6_20150309_00006.jpg

LM Start	0.45	Rating **	M	Issue No.	6
LM End	0.45	Issue Type +	Ma	Location *	WS
Category	Earthen Levee			GPS Latitude/Longitude	
				Start	End
Item	Encroachments			37.864713 °	37.864713 °
				-121.326708 °	-121.326708 °
DWR ID	DWR_RD0544_01_f_2013_6				
Action/Comments					
Prunings					
Inspector Comments: Broken tree limbs on waterward slope and berm.

Looking southeast at tree branch on waterward slope.

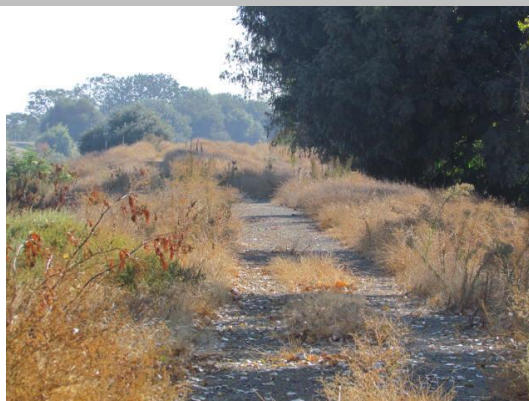
Photo 2 of 2 : SP_2015_RD0544_108_3_20150309_00002.jpg

Looking south at overgrown on landward and waterward slopes.

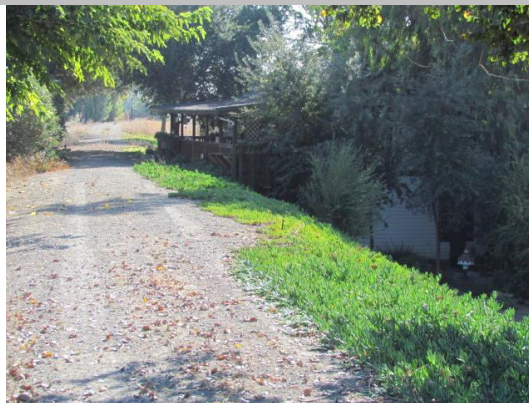
Photo 1 of 1 : SP_2015_RD0544_108_9_20150309_00008.jpg

Looking south at landscaping on landward slope.

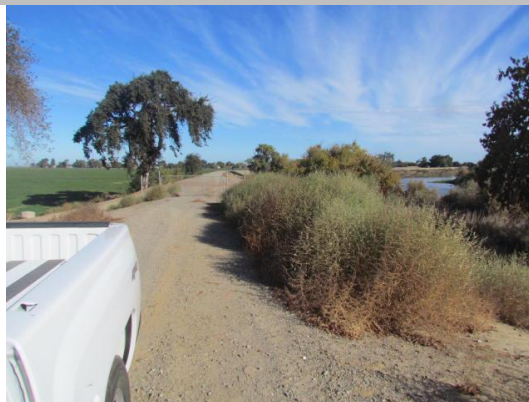
Photo 1 of 1 : SP_2015_RD0544_108_94_20150309_00054.jpg

Looking north at vegetation on waterward shoulder and slope.

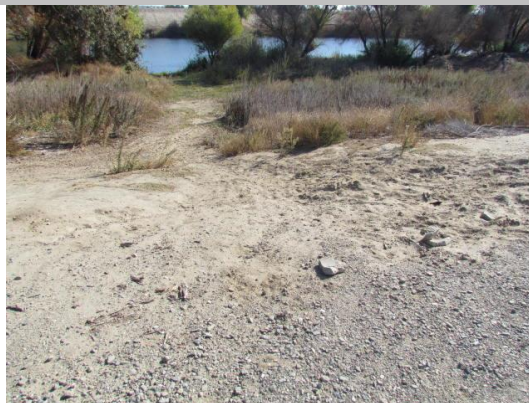
Photo 1 of 2 : SP_2015_RD0544_108_64_20150309_00043.jpg

LM Start	1.56	Rating **	M	Issue No.	64
LM End	1.56	Issue Type +	Ma	Location *	WS
Category	Earthen Levee			GPS Latitude/Longitude	
				Start	End
Item	Slope Stability			37.854081 °	37.854081 °
				-121.321268 °	-121.321268 °
DWR ID	DWR_RD0544_01_f_2013_64				
Action/Comments					
Repair the levee slope damaged by vehicle traffic and prevent access where possible.					
Inspector Comments: Damaged levee slope due to fishermen using slope as a ramp.

Looking east at damaged waterward slope.

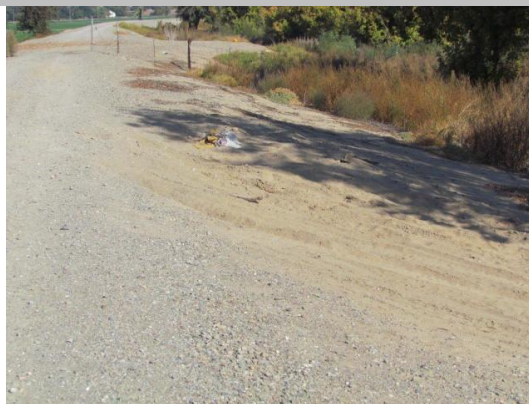
Photo 2 of 2 : SP_2015_RD0544_108_64_20150309_00044.jpg

Looking northeast at waterward slope.

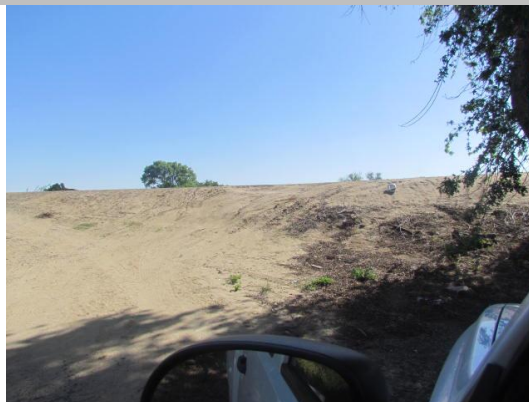
Photo 1 of 1 : SP_2015_RD0544_108_5_20150309_00005.jpg

LM Start	1.82	Rating **	M	Issue No.	5
LM End	1.82	Issue Type +	Ma	Location *	LS
Category	Earthen Levee			GPS Latitude/Longitude	
				Start	End
Item	Slope Stability			37.853188 °	37.853188 °
				-121.324145 °	-121.324145 °
DWR ID	DWR_RD0544_01_s _ 2013_5				
Action/Comments					
Repair the levee slope damaged by vehicle traffic and prevent access where possible.					
Inspector Comments: Slope damaged by vehicle traffic.

Looking east at landward slope damaged by vehicle traffic.

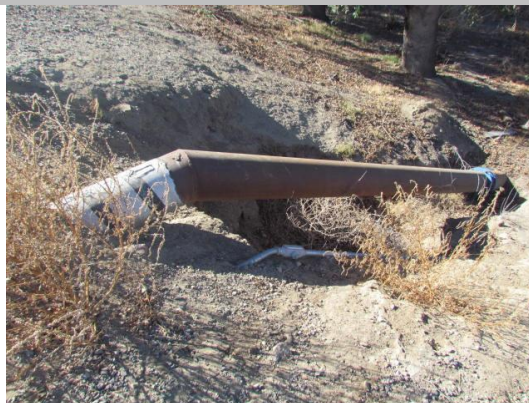
Photo 1 of 3 : SP_2015_RD0544_108_23_20150309_00024.jpg

LM Start	2.26	Rating **	U	Issue No.	23
LM End	2.26	Issue Type +	Ma	Location *	LS
Category	Earthen Levee			GPS Latitude/Longitude	
				Start	End
Item	Erosion / Bank Caving			37.848155 °	37.848155 °
				-121.324897 °	-121.324897 °
DWR ID	DWR_RD0544_01_s_2012_23				
Action/Comments					
Schedule repair of erosion site prior to the next inspection.					
Inspector Comments: Caving/erosion around irrigation pipe on landside slope.

Looking south at erosion around irrigation pipe on landside slope. (Fall 2014)

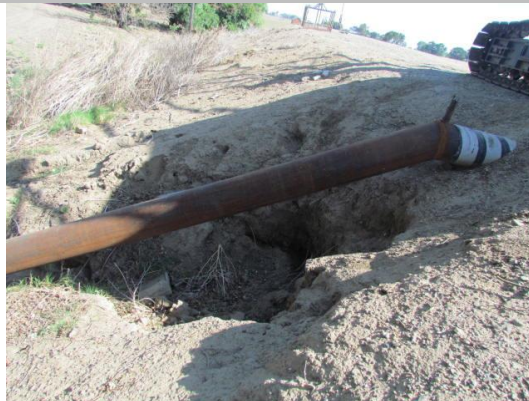
Photo 2 of 3 : SP_2015_RD0544_108_23_20150309_00025.jpg

LM Start	2.26	Rating **	U	Issue No.	23 (cont)
LM End	2.26	Issue Type +	Ma	Location *	LS
Category	Earthen Levee			GPS Latitude/Longitude	
				Start	End
Item	Erosion / Bank Caving			37.848155 °	37.848155 °
				-121.324897 °	-121.324897 °
DWR ID	DWR_RD0544_01_s_2012_23				
Action/Comments					
Schedule repair of erosion site prior to the next inspection. Inspector Comments: Caving/erosion around irrigation pipe on landside slope.

Looking north at erosion under irrigation pipe on landside slope.

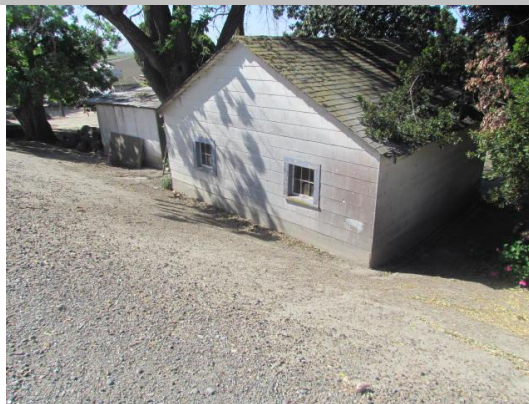
Photo 1 of 1 : SP_2015_RD0544_108_67_20150309_00045.jpg

Looking southeast at building at landward toe.

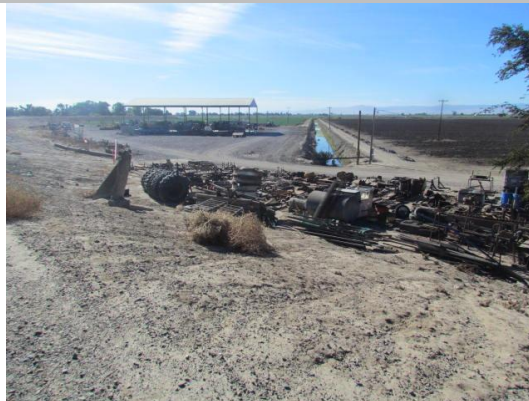
Photo 1 of 1 : SP_2015_RD0544_108_68_20150309_00046.jpg

Looking west at equipment at landward toe.

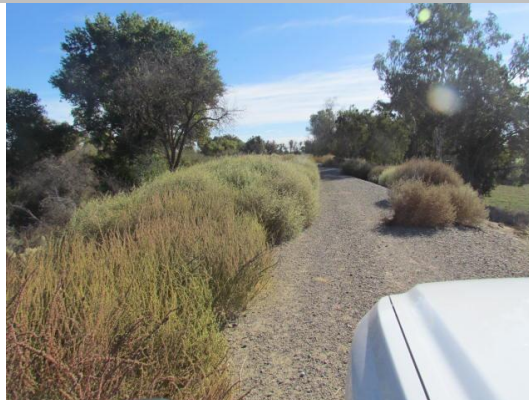
Photo 1 of 1 : SP_2015_RD0544_108_99_20150309_00055.jpg

Looking south at dense vegetation on waterward shoulder and slope.

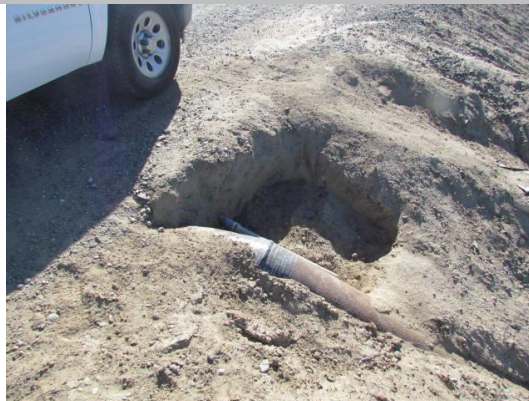
Photo 1 of 2 : SP_2015_RD0544_108_91_20150309_00052.jpg

Looking south at partially open trench around pipe on landward shoulder and slope.

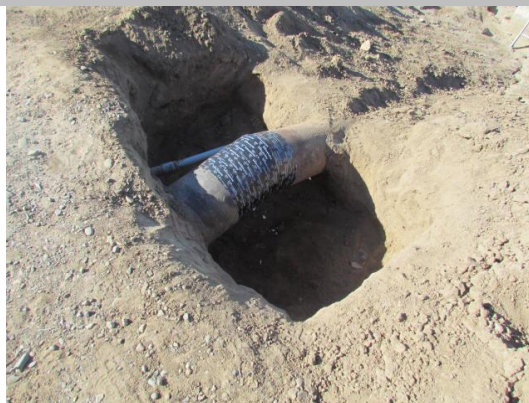
Photo 2 of 2 : SP_2015_RD0544_108_91_20150309_00053.jpg

Looking at open trench with irrigation pipe on landward shoulder and slope.

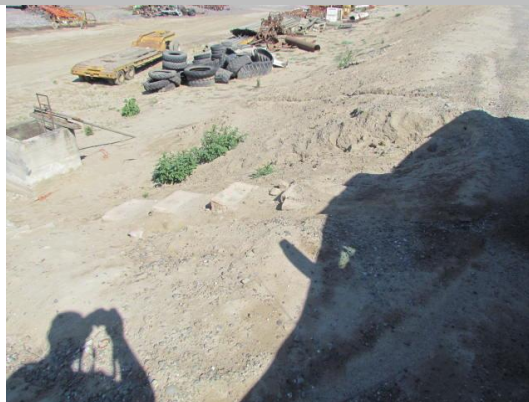
Photo 1 of 2 : SP_2015_RD0544_108_60_20150309_00039.jpg

Looking north at slope damage on landside slope.

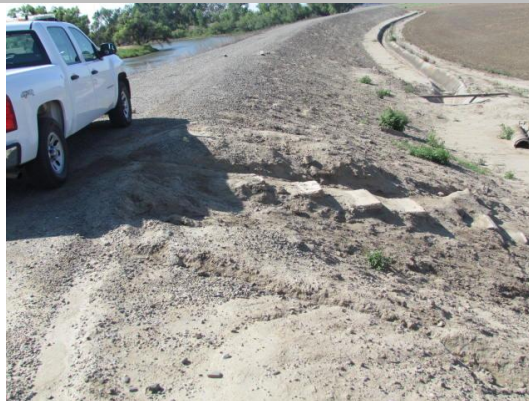
Photo 2 of 2 : SP_2015_RD0544_108_60_20150309_00040.jpg

Looking south at slope damage on landside slope.

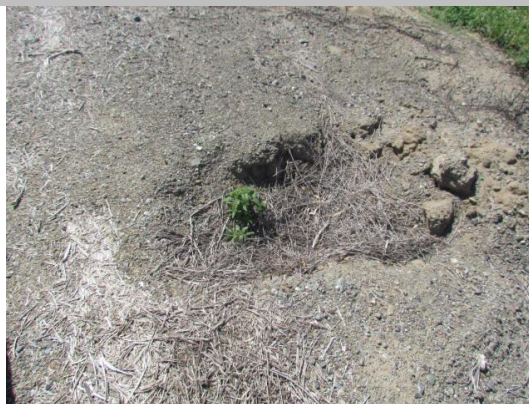
Photo 2 of 2 : SP_2015_RD0544_108_107_20150430_00079.jpg

Looking west at depression on landward shoulder.

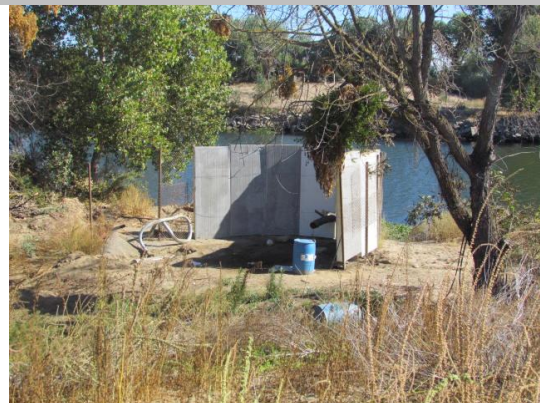
Photo 1 of 12 : SP_2015_RD0544_108_16_20150309_00010.jpg

Looking east at concrete wall on waterward berm.

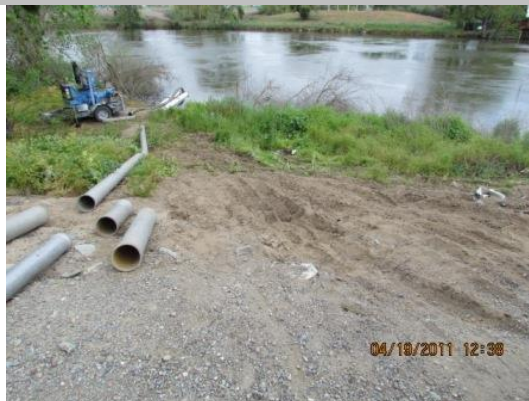
Photo 5 of 12 : SP_2015_RD0544_108_16_20150309_00014.jpg

Looking east at landowner installing temporary pump system without permit and damage to waterside slope.

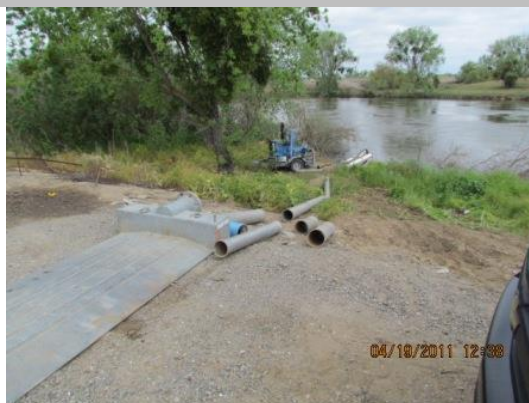
Photo 6 of 12 : SP_2015_RD0544_108_16_20150309_00015.jpg

Looking east at pump and irrigation ramp on levee waterside and crown.

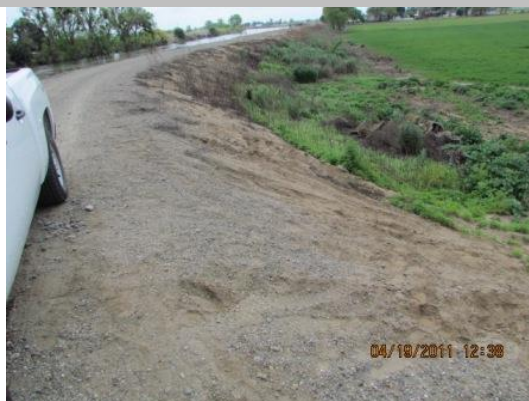
Photo 7 of 12 : SP_2015_RD0544_108_16_20150309_00016.jpg

Looking south at damage landside slope caused by vehicle traffic.

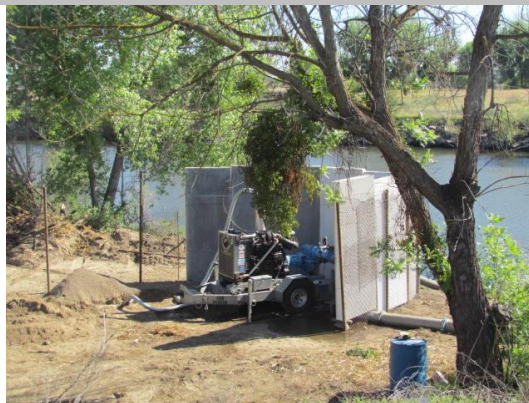
Photo 8 of 12 : SP_2015_RD0544_108_16_20150309_00017.jpg

Looking east at concrete wall around temporary pump on waterward berm. (Spring 2014)

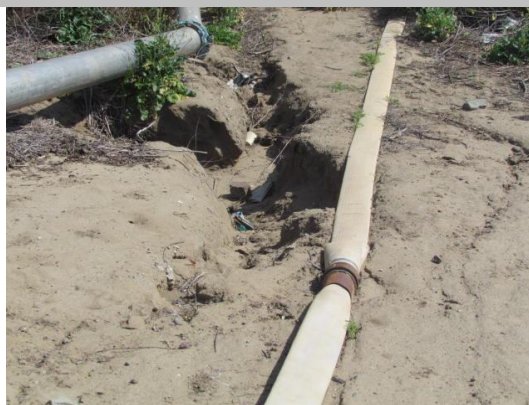
Photo 9 of 12 : SP_2015_RD0544_108_16_20150309_00018.jpg

Looking east at erosion caused by leaking pipe on waterside slope.

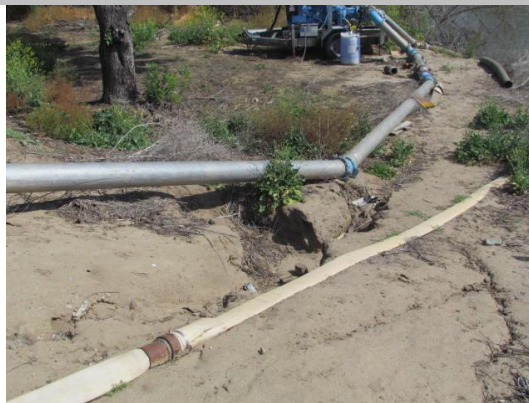
Photo 10 of 12 : SP_2015_RD0544_108_16_20150309_00019.jpg

Looking northeast at unauthorized pump system on waterside slope.

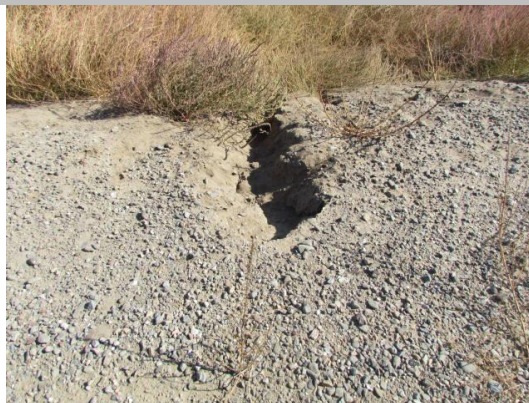
Photo 1 of 1 : SP_2015_RD0544_108_76_20150309_00047.jpg

Looking east at slope damage on waterward slope.

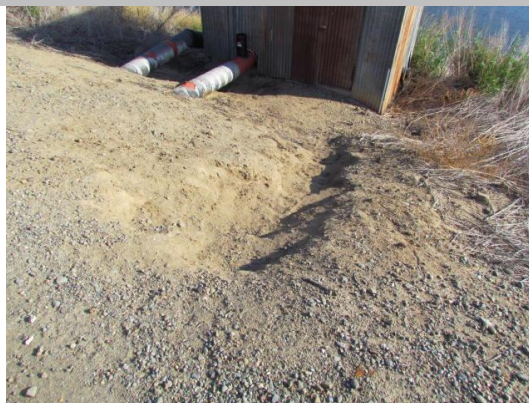
Photo 1 of 1 : SP_2015_RD0544_108_62_20150309_00041.jpg

Looking east at slope damaged by foot traffic near pump house on waterside of levee.

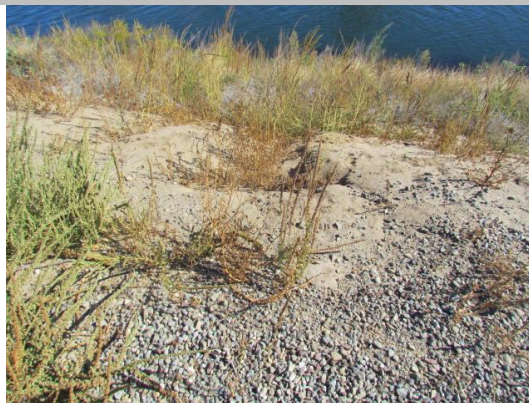
Photo 1 of 1 : SP_2015_RD0544_108_50_20150309_00036.jpg

Looking east at erosion on waterward slope.

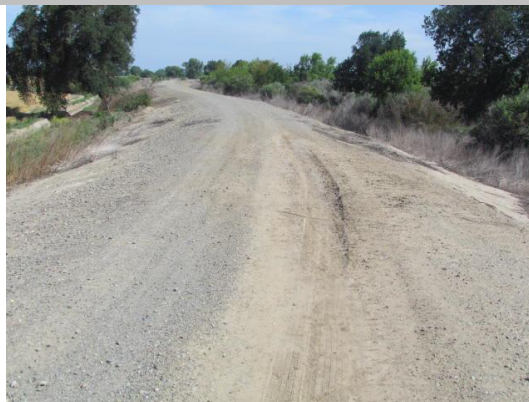
Photo 1 of 1 : SP_2015_RD0544_108_63_20150309_00042.jpg

Looking south at one of several sites needing gravel or road base on levee crown.

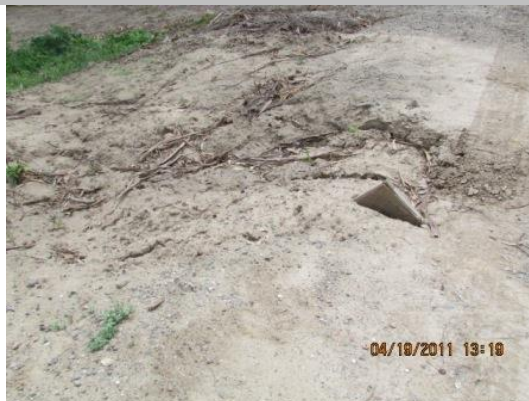
Photo 1 of 2 : SP_2015_RD0544_108_58_20150309_00037.jpg

Looking southeast at depression on waterside shoulder.

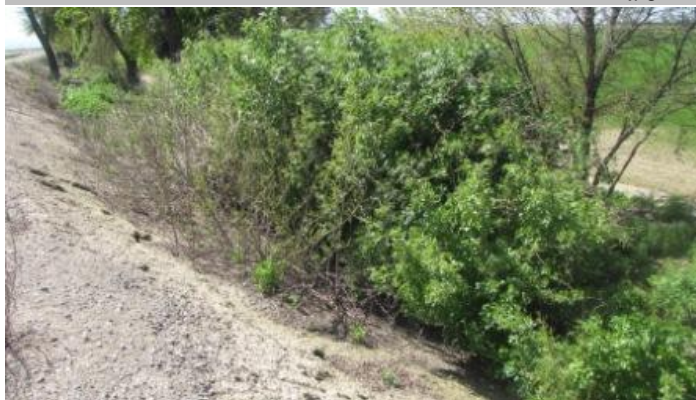
Photo 1 of 1 : SP_2015_RD0544_108_41_20150309_00034.jpg

Looking south at elderberries on landside slope and toe.

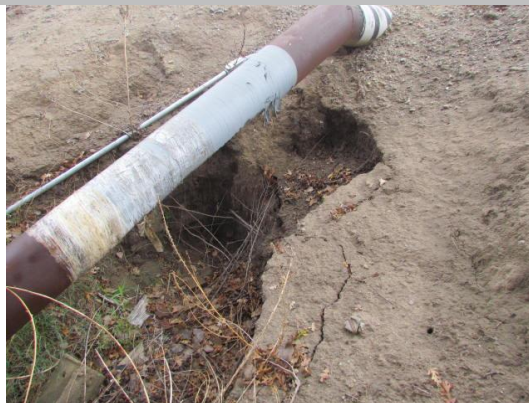
Photo 1 of 2 : SP_2015_RD0544_108_28_20150309_00027.jpg

Looking northeast at erosion around irrigation pipe on landside slope.

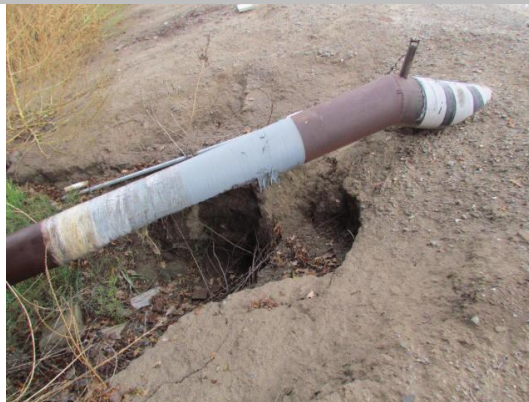
Photo 2 of 2 : SP_2015_RD0544_108_28_20150309_00028.jpg

Looking north at erosion around irrigation pipe on landside

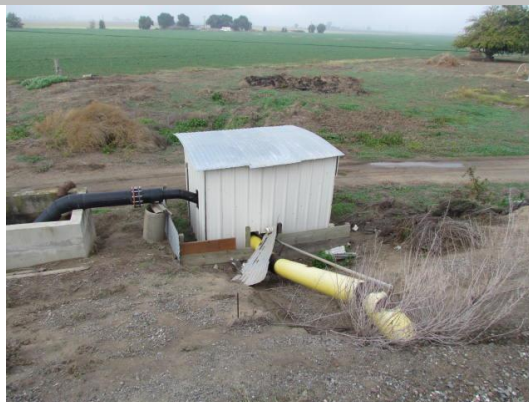
Photo 1 of 1 : SP_2015_RD0544_108_45_20150309_00035.jpg

Looking west at a unauthorized pump house on landside toe.

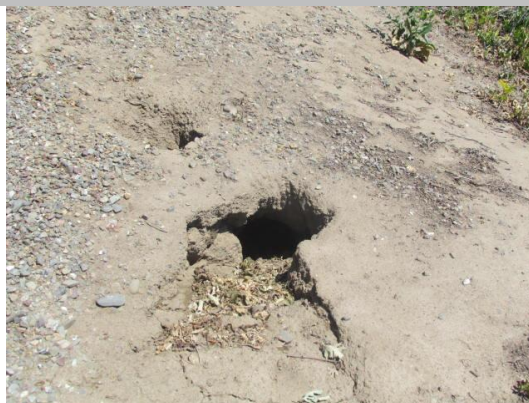
Photo 1 of 1 : SP_2015_RD0544_108_113_20150430_00083.jpg

Looking north at large hole on waterward slope.

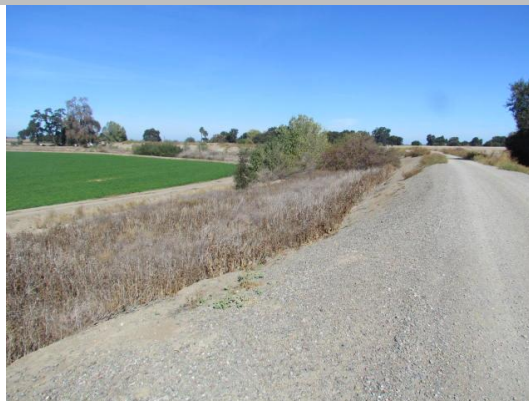
Photo 3 of 5 : SP_2015_RD0544_108_33_20150309_00029.jpg

Looking north at dead vegetation still blocking landward toe.

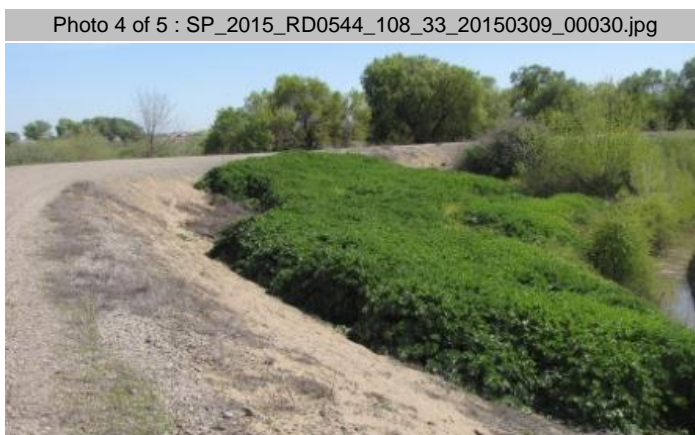
LM Start	4.95	Rating **	M	Issue No.	33 (cont)
LM End	5.26	Issue Type +	Ma	Location *	LS
Category	Earthen Levee			GPS Latitude/Longitude	
				Start	End
Item	Vegetation			37.818718 °	37.814662 °
				-121.319508 °	-121.320302 °
DWR ID	DWR_RD0544_01_s_2012_33				
Action/Comments					
Remove the wild growth other than native grasses from the levee slopes.					
Inspector Comments: Vegetation has been sprayed, but still blocking view of landward toe.

Looking southeast at dense veg. on landside slope and toe.

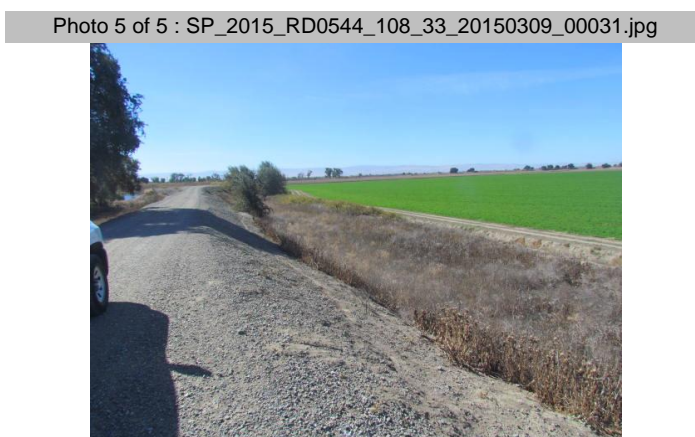
LM Start	4.95	Rating **	M	Issue No.	33 (cont)
LM End	5.26	Issue Type +	Ma	Location *	LS

Looking south at dead vegetation still blocking landward toe.

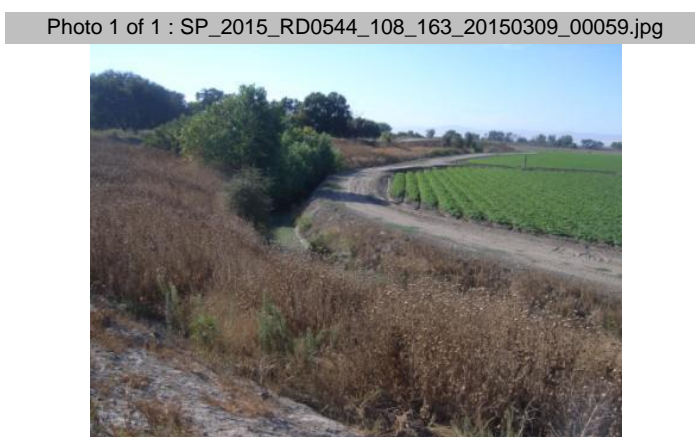
LM Start	4.96	Rating **	U	Issue No.	163
LM End	5.01	Issue Type +	En	Location *	LS
Category	Earthen Levee			GPS Latitude/Longitude	
				Start	End
Item	Encroachments				37.818125 °
					-121.319070 °
DWR ID	DWR_RD0544_01_s_2012_163				
Action/Comments					
Ditch					
Inspector Comments: Agricultural ditch on landside toe.

Looking southwest at ditch on landside slope and toe.

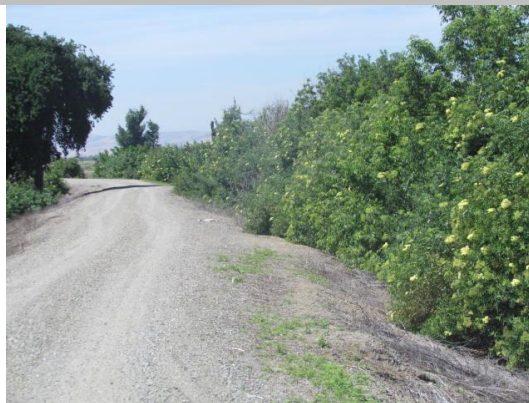
Photo 1 of 3 : SP_2015_RD0544_108_18_20150430_00086.jpg

Looking south at dense vegetation on landward slope and toe.(Spring 2015)

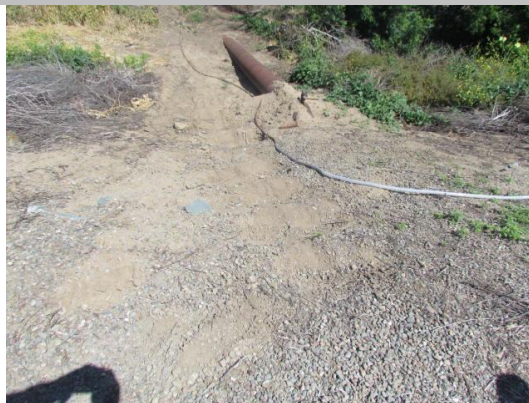
Photo 1 of 3 : SP_2015_RD0544_108_115_20150430_00087.jpg

Looking west at slope damage on landward slope.

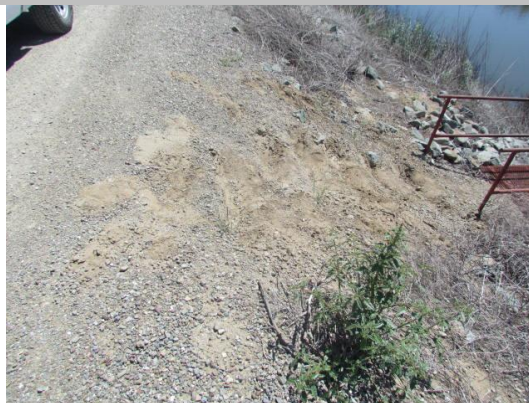
Photo 2 of 3 : SP_2015_RD0544_108_115_20150430_00088.jpg

Looking east at slope damage on waterward slope.

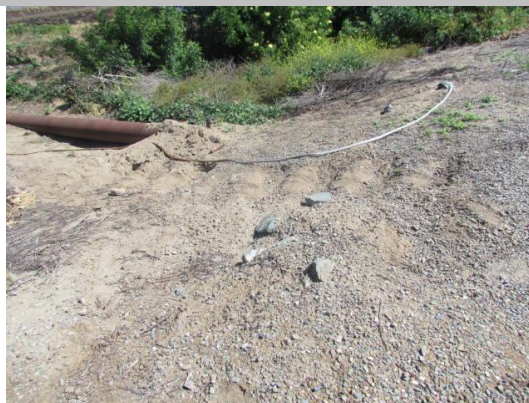
Photo 3 of 3 : SP_2015_RD0544_108_115_20150430_00089.jpg

Looking northwest at slope damage on landward toe.

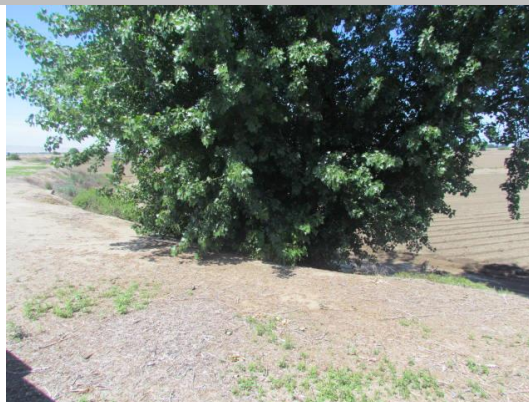
Photo 1 of 1 : SP_2015_RD0544_108_117_20150430_00090.jpg

Looking west at untrimmed tree on landward slope.

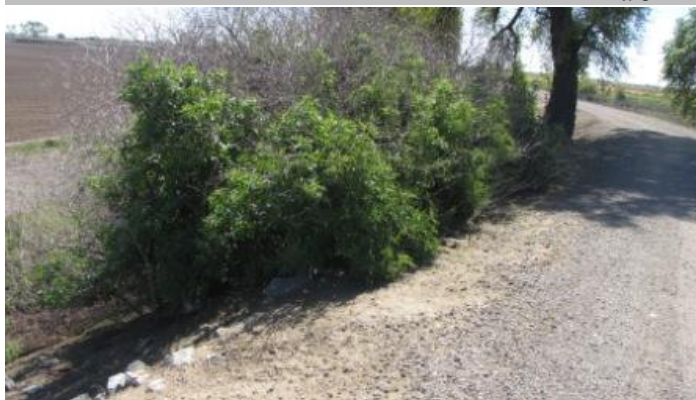
Photo 1 of 3 : SP_2015_RD0544_109_4_20150309_00001.jpg

Looking northwest at elderberries on landside slope and toe.

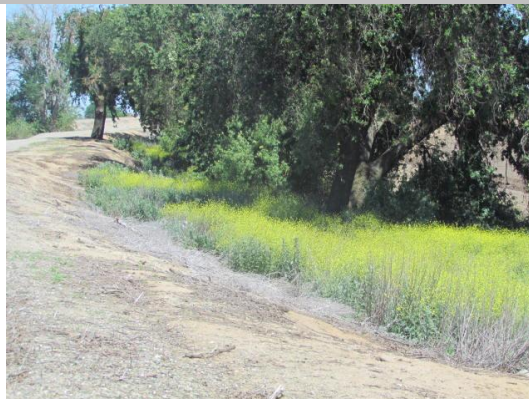
Photo 1 of 1 : SP_2015_RD0544_109_1_20150430_00054.jpg

Looking southwest at dense vegetation at landward toe.

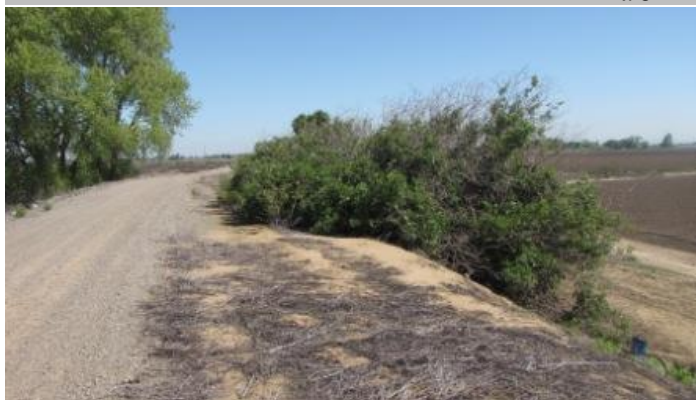
Photo 1 of 1 : SP_2015_RD0544_109_5_20150309_00004.jpg

Looking south at elderberries on landside slope and toe.

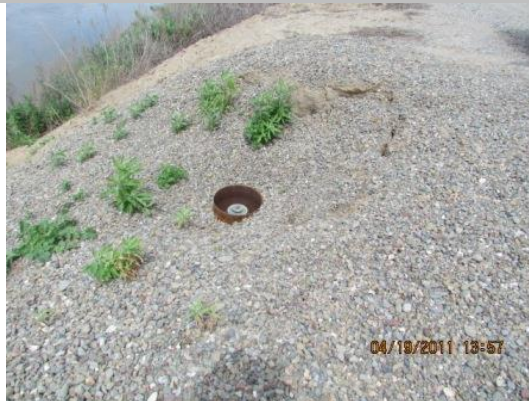
Photo 3 of 8 : SP_2015_RD0544_109_8_20150309_00008.jpg

Looking south at depression greater than 6" on waterside shoulder.

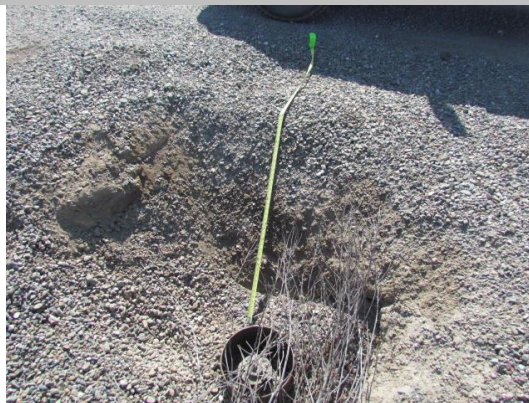
Photo 6 of 8 : SP_2015_RD0544_109_8_20150309_00011.jpg

Looking west at caving around siphon on waterside shoulder. (Spring 2012)

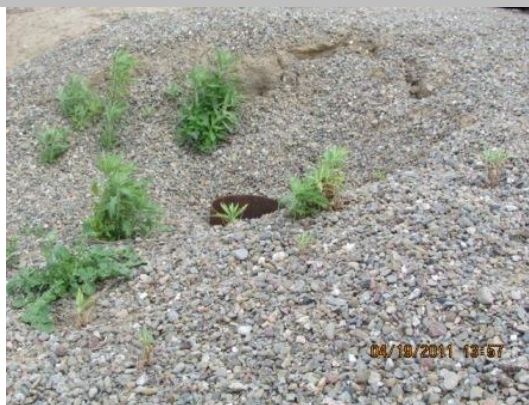
Photo 8 of 8 : SP_2015_RD0544_109_8_20150309_00013.jpg

Looking south at depression greater than 6" around siphon on waterside shoulder.

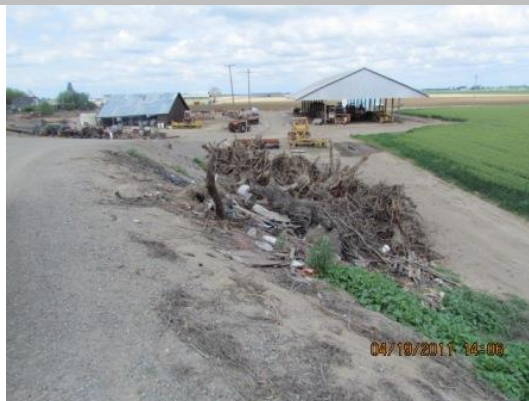
Photo 2 of 4 : SP_2015_RD0544_109_20_20150309_00025.jpg

Looking southwest at pruning pile on landside slope.

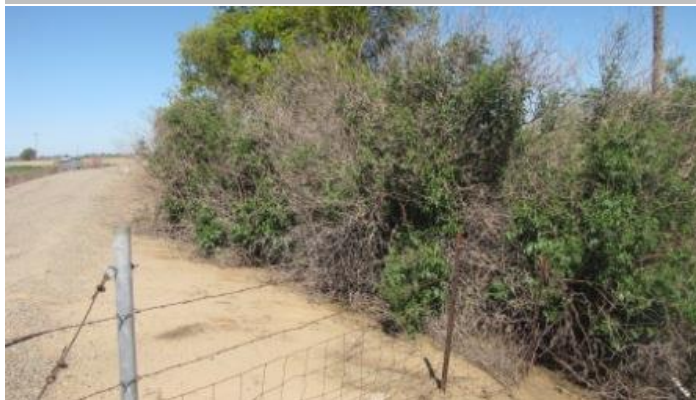
Photo 2 of 2 : SP_2015_RD0544_109_10_20150309_00016.jpg

Looking south at elderberries on landside slope and toe.

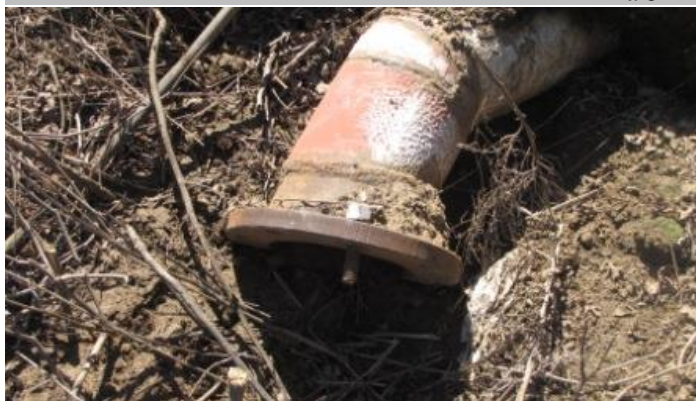
Photo 1 of 3 : SP_2015_RD0544_109_21_20150309_00028.jpg

Looking east at pipe on landside slope.

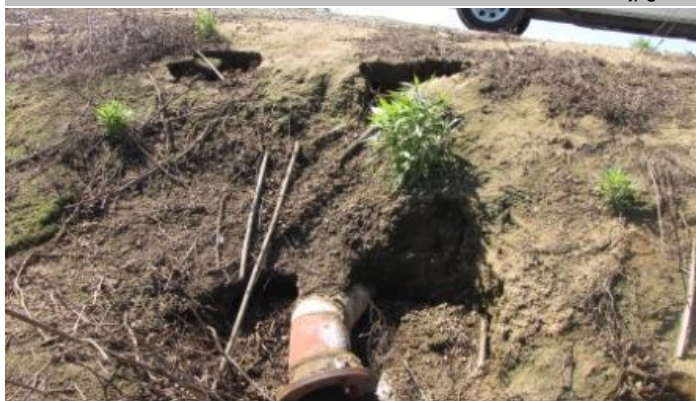
Photo 3 of 3 : SP_2015_RD0544_109_21_20150309_00030.jpg

Looking east at pipe and erosion just above pipe on landside slope and shoulder.

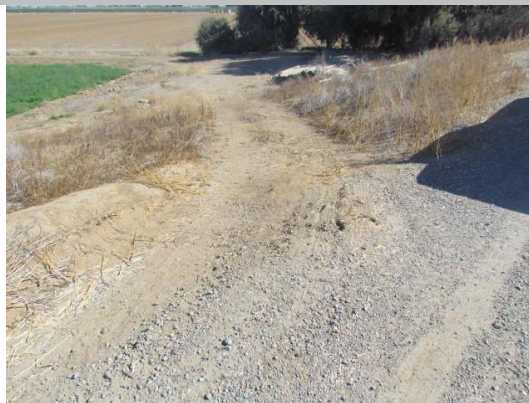
Photo 1 of 2 : SP_2015_RD0544_109_22_20150309_00031.jpg

Looking northwest at slope damage caused by vehicle traffic (Fall 2014).

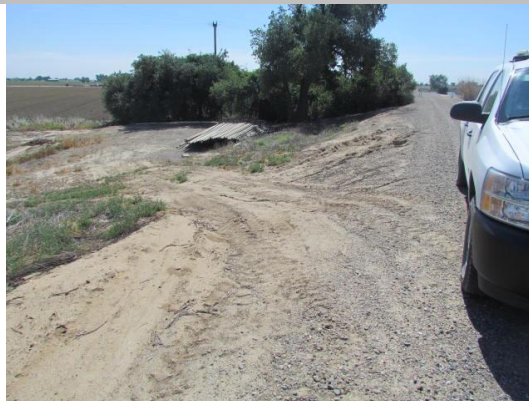
Photo 2 of 2 : SP_2015_RD0544_109_22_20150309_00032.jpg

Looking northwest at slope damage caused by vehicle traffic.

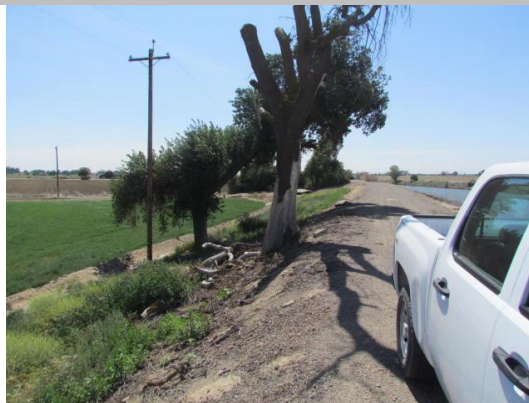
Photo 1 of 1 : SP_2015_RD0544_109_23_20150309_00033.jpg

Looking north at dead tree and tree limbs on landside shoulder and slope.

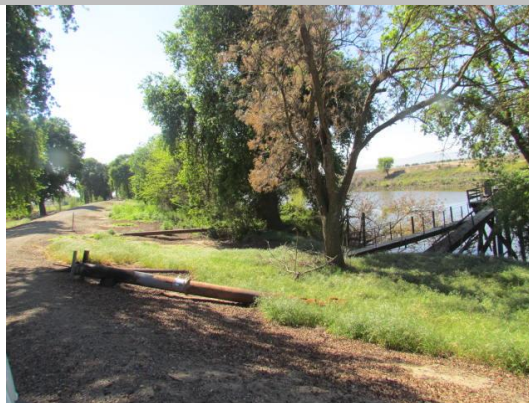
Photo 1 of 1 : SP_2015_RD0544_109_51_20150309_00042.jpg

Looking north at old pump shaft and pipe on waterward slope.

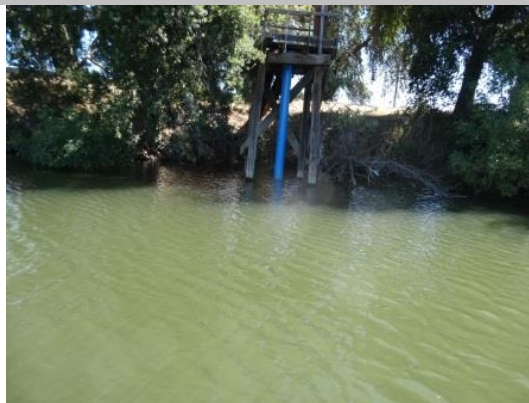
Photo 1 of 1 : SP_2015_RD0544_109_12_20150309_00017.jpg

Front view of the erosion site. View is partially blocked by the pump structure and vegetation.

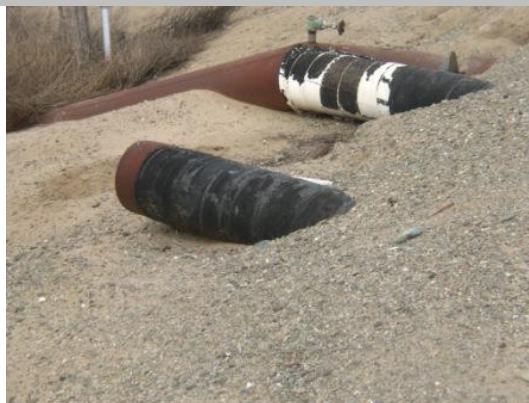
Photo 1 of 1 : SP_2015_RD0544_109_15_20150309_00019.jpg

Abandoned pipe at LM 2.65, landside view.

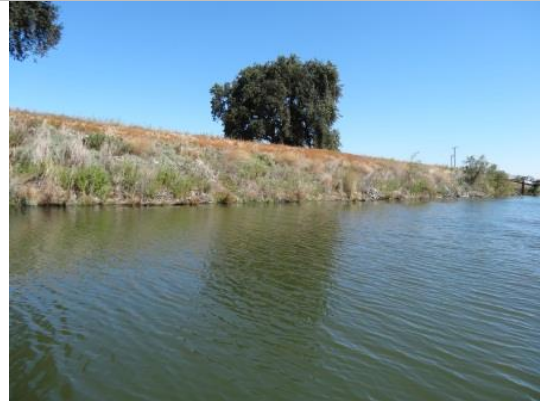
Photo 1 of 1 : SP_2015_RD0544_109_9_20150309_00014.jpg

Front view of pocket erosion. Note the vegetation and riprap at the site.

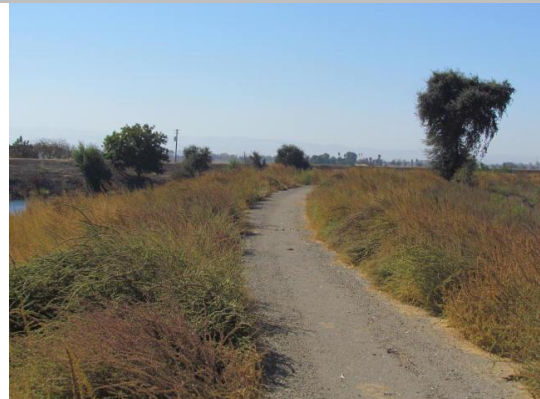
Photo 1 of 1 : SP_2015_RD0544_109_43_20150309_00039.jpg

Looking south at dense vegetation on landward and waterward slope.

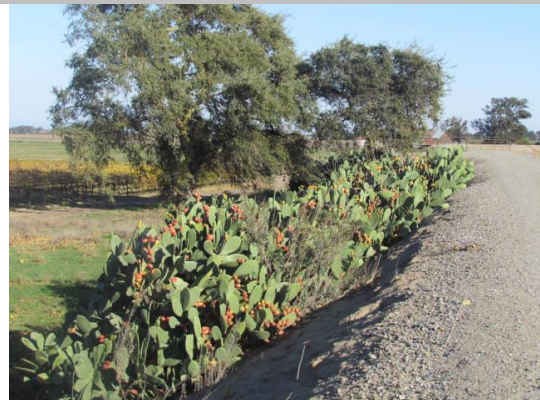
Photo 1 of 2 : SP_2015_RD0544_109_36_20150309_00037.jpg

Looking north at cactus on landside slope and toe.

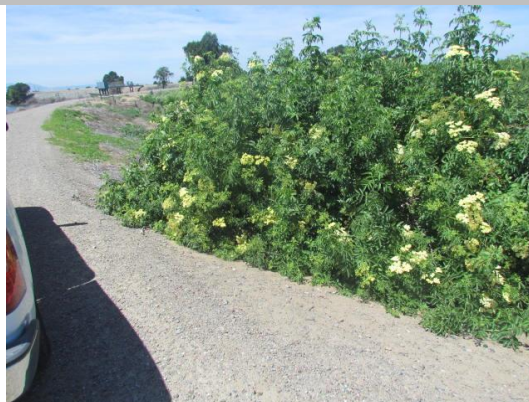
Photo 1 of 1 : SP_2015_RD0544_109_64_20150430_00061.jpg

Looking southwest at dense elderberry bush on landward slope and toe.
(Spring 2015)

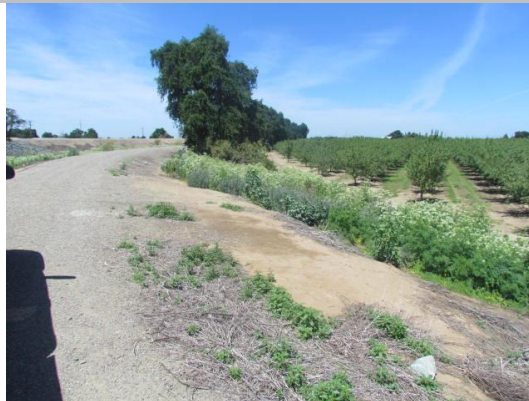
Photo 1 of 1 : SP_2015_RD0544_109_65_20150430_00062.jpg

Looking southwest at dense vegetation on landward slope and toe.
(Spring 2015)
